Investigation of Cold Cathodes
for
Long Life CO₂ Waveguide Lasers

Final Report
for Contract F49620-79-C-0076

U. Hochuli

November 1981

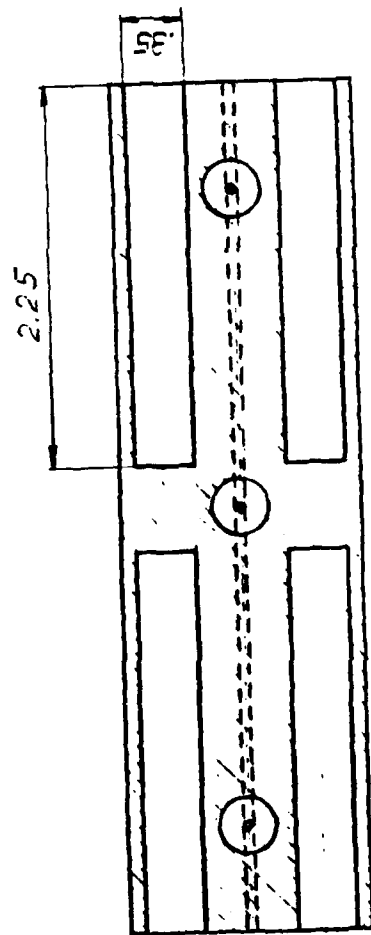
Fig. 1

Careful observations on the more than 50 different cathodes being tested indicate that semiconducting, sintered NiO is one of the better cathode materials. Such cathodes were actually used to generate the life test data with two of the BeO laser structures shown in Figure 1. Both of these lasers used three cathode type electrodes, one located 5/8" from each bore end and one near the bore center. Laser No 1 used both end electrodes as 2mA cathodes and the center electrode as the common 4mA anode. Laser No 2 worked with the end electrodes as 2mA anodes and used the center electrode as a common 4mA cathode. From the discharge tube results we know that the 4mA cathode is prone to considerably heavier sputtering than the 2mA cathode. Both lasers had indium "O" ring and indium film seals developed by us 11 years ago. All the seals on Laser No 1 were perfect but Laser No 2 had

a very small crack in the BeO body which was sealed with "Black Seal" liquid.

LASER STRUCTURE
(BeO)
